Outcomes Design Engineering
 Road Space Management
 3rd Floor, Palestra
 197 Blackfriars Road
 London SE1 8NJ
www.tfl.gov.uk

EVALUATION OF THE EFFECT OF SLOW MARKINGS ON TRAFFIC SPEEDS

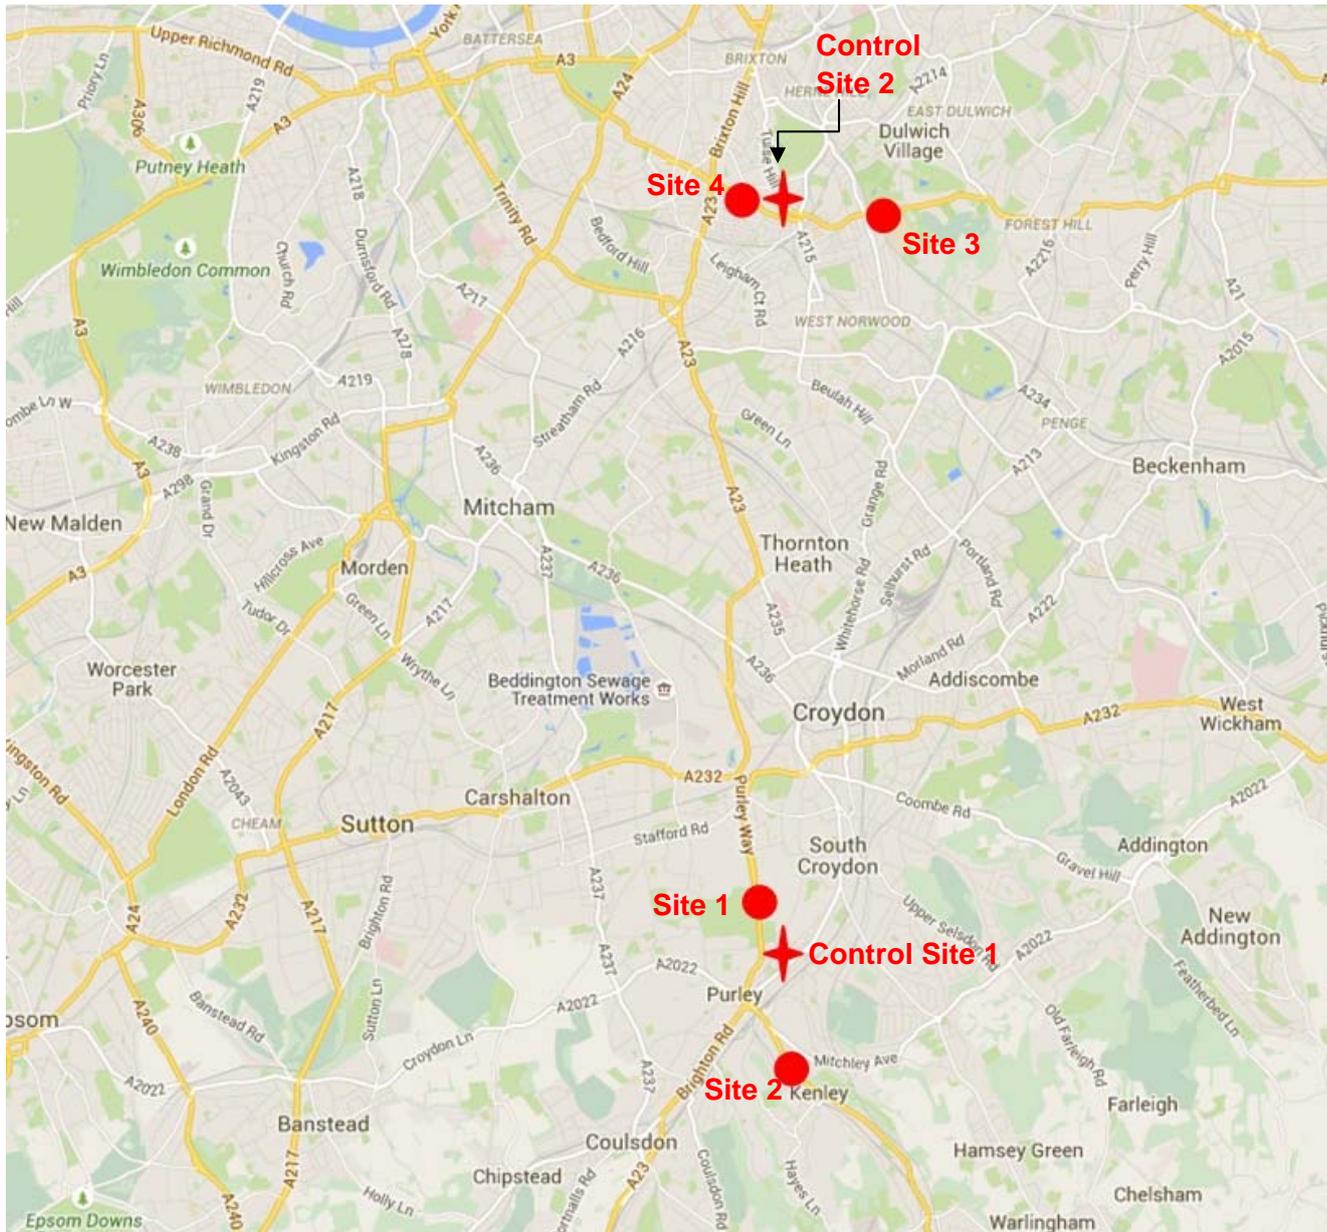
Site Locations

Four locations were chosen, two of which had slow markings installed in both directions making a total of six trial sites. The sites were chosen where the impact of the marking could be isolated. Traffic speed data was obtained prior to the installation of the SLOW markings, and after, using two methods:

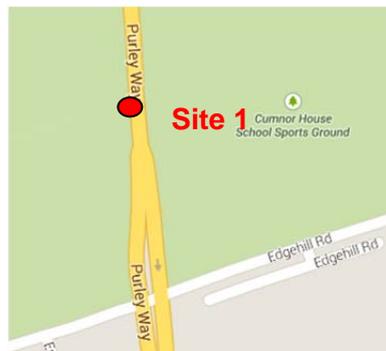
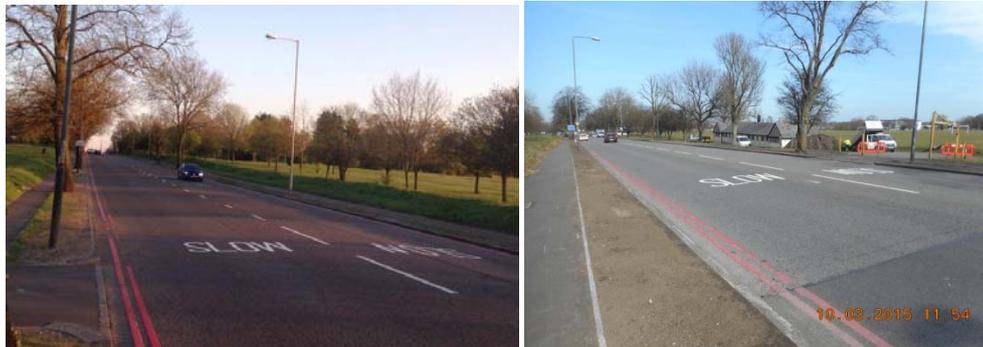
Site 1 – A23 Purley Way

The A23 Purley Way is situated in Purley with a speed limit of 40mph. SLOW markings were installed in both directions along the stretch adjacent to Cumnor House School Sports Ground as there is little congestion during peak hours and where no speed reduction measures existed. The majority of speeds along this straight road are between 40mph and 90 mph.

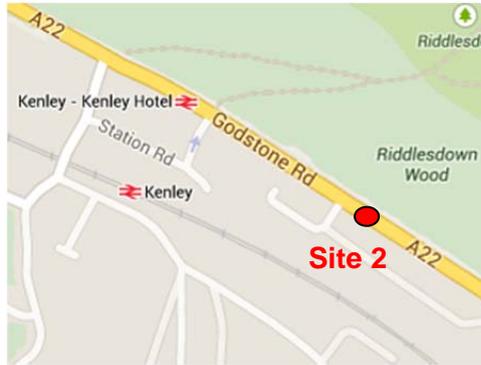
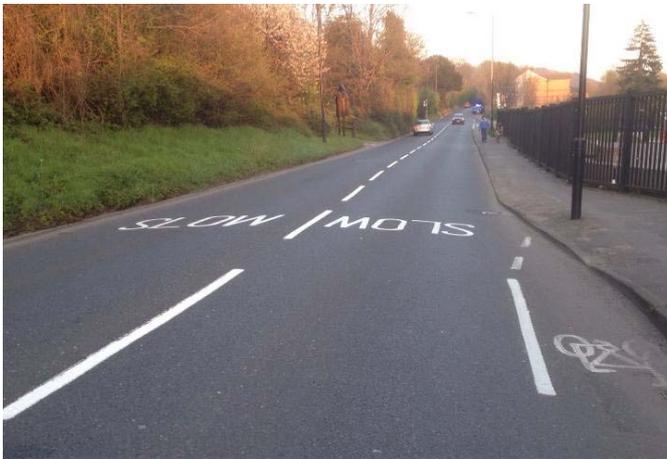
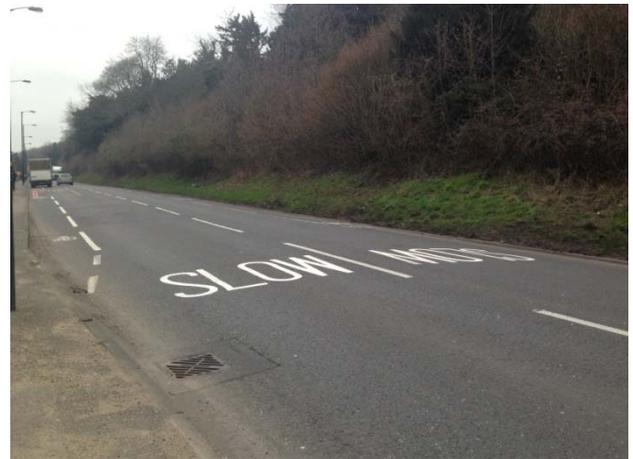
Site 2 – A22 Godstone Road

The A22 Godstone Road is a 30mph road located in Kenley. SLOW markings were installed in both directions on Godstone Road. Most traffic speeds along the stretch of road beside Riddlesdown Wood lie between 30mph and 50mph. Godstone road has few side roads and an irregular bus service.

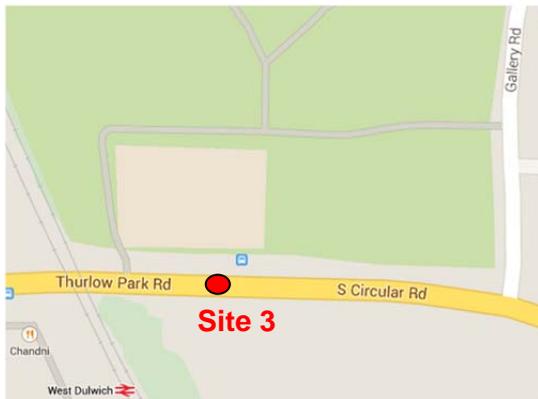
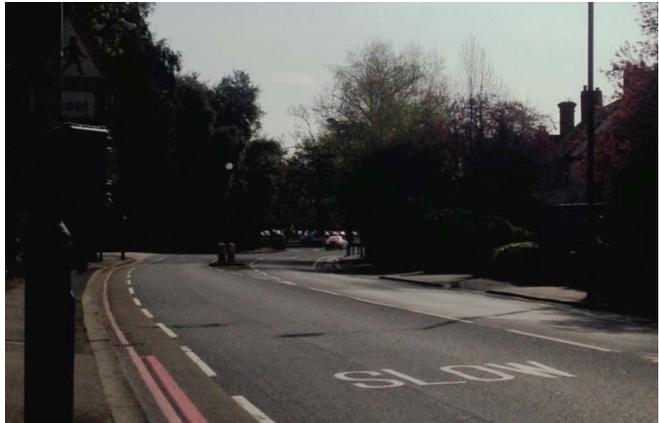
Site 3 – Thurlow Park Road

Thurlow Park Road has a speed limit of 30mph, situated in Dulwich along the South Circular Road. There are a number of schools in the area and the marking was installed alongside an existing school warning sign and on the approach to a bend.

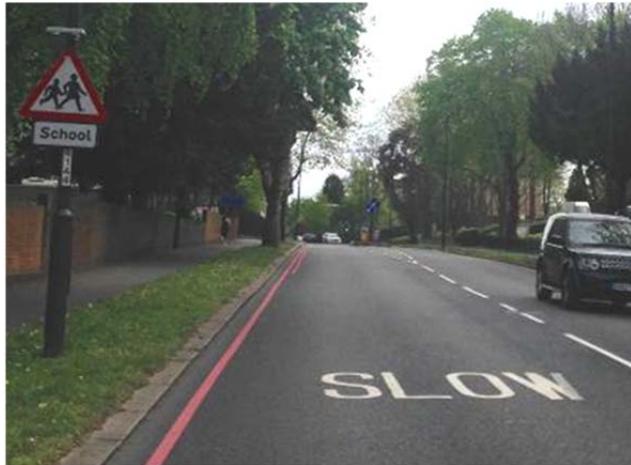
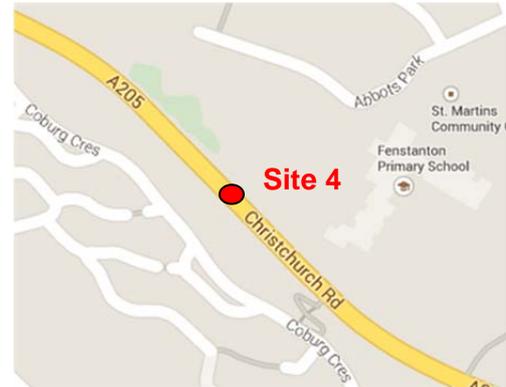
Site 4 – Christchurch Road

Christchurch Road has a speed limit of 30mph, situated in Streatham. The SLOW marking site is close by to Fenstanton Primary School where there is an informal crossing. Again it was installed adjacent to an existing warning sign.

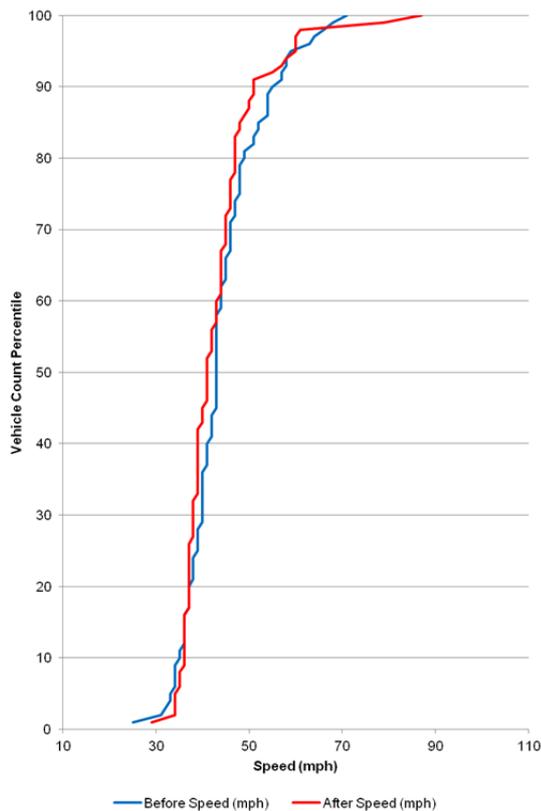
SLOW Marking Site 2 – Godstone Road (Northbound)

As an interesting comparison, the A232 Wickham Road is a site where [centre line markings were removed](#) from the carriageway. Graphs have been created to visually represent the data collated from the radar speed gun at a slow marking site and a centre line removal site. The expectation is that at a site where engineering measures have reduced speed, the 'After' line should shift to the left of the 'Before.' Considering the effect of the centre line removal, there is a distinct separation between the before and after speed graph lines; the entire 'After' graph line has shifted to the left of the 'Before.' This separation is evidence of the reduction of traffic speed due to the centre line removal. However, the SLOW marking graph lines do not display such a distinct separation, instead the before and after speed graph lines are intertwined. This visual representation alone shows that the SLOW markings were not effective at reducing speeds.
